## Aviation Safety

# Vortex

Learn from the mistakes of others; you'll not live long enough to make them all yourself . . . Issue 3/2000

## Accidents Never Change—Only People Change

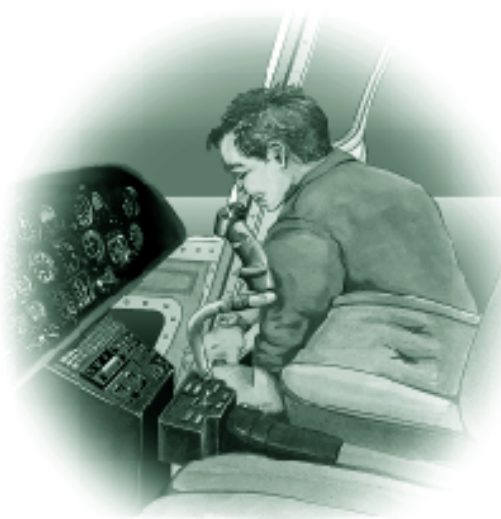
A re-enactment of the procedure used to remove the right front door revealed that while removing the lower door closer air spring, the mechanic's left shoulder could easily come in contact with the cyclic.

With the hydraulic system on and the cyclic friction set at about the midpoint (the way it was found after the accident), the cyclic position could be displaced forward and to the left during door removal with minimal effort. Left forward movement of the cyclic would lower the disk in the exact area the pilot approached from.

The safest practice by far is never to leave the helicopter unattended. How much time are you really saving by not shutting down? There are companies in the industry who have a very clear policy on leaving their aircraft running without a pilot at the controls and that policy is—do it and you're fired. 🚁
